Historic Bridge Rehabilitation Analysis Phase 1 SR 1002 (Skinners Falls Road) over Delaware River

BMS# 63-1002-0230-0739

AECOM

May 2023

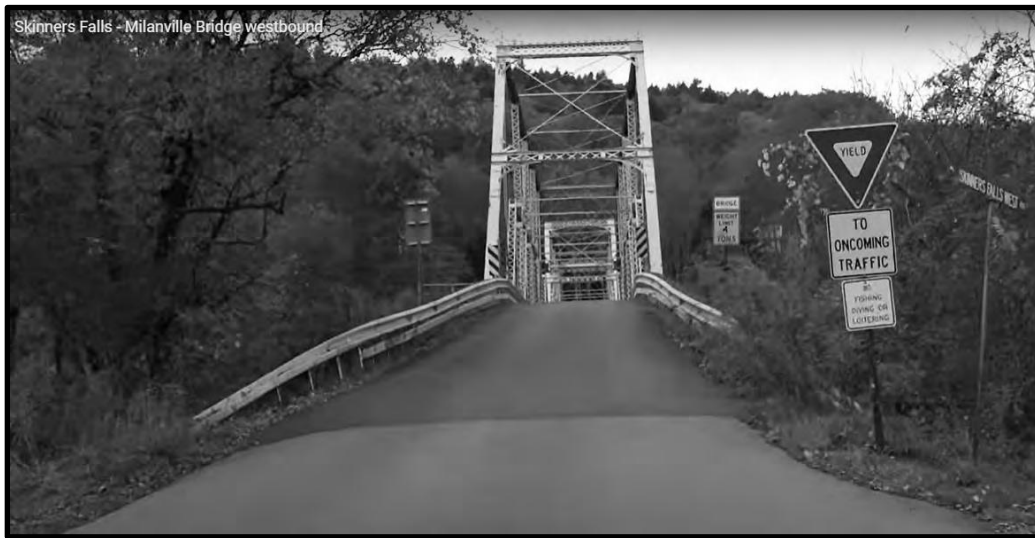
When open, the bridge operated as a single lane structure with two-way traffic, yield controlled on either end of the bridge. The driver's view from the east (NY) side of the bridge heading westbound is pictured below (**Figure 2**), showing the yield condition and signage indicating that vehicles should yield to oncoming traffic. This approach has poor sight of the opposing (PA) traffic due to the bridge being situated at a higher elevation relative to the roadway approaching the bridge. The difference in elevation, along with the steepness in slope between the approach and the bridge elevations limits driver's ability to see whether vehicles, pedestrians or bicyclists are on the bridge. As noted, crash history data from NYSDOT was not readily available. PennDOT crash history data on the PA approach of the bridge did not indicate

a safety concern. However, sight distance across the bridge is substandard and problematic given the one lane available for vehicular travel.

Figure 2: New York Approach geometry with a view west of the approach on the east (New York) side of the bridge.

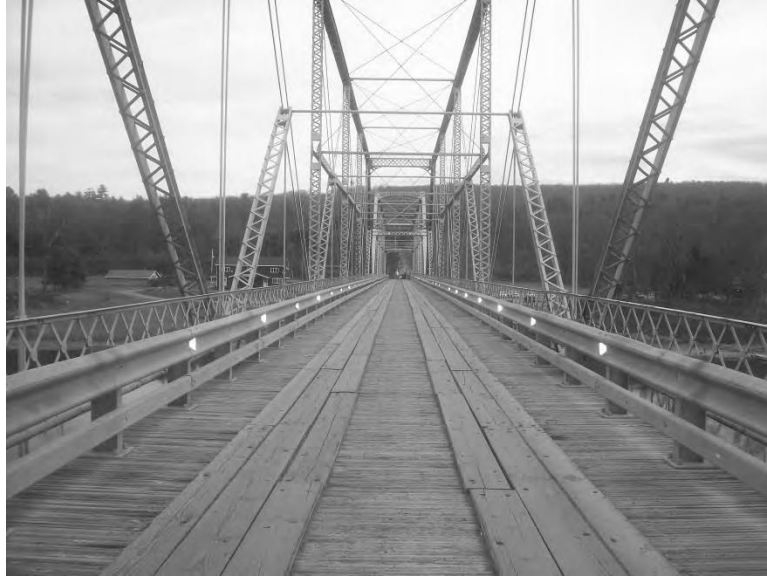
Guiderail is present at all four corners and guiderail was mounted on both edges of the timber deck during the 1986 rehabilitation. The original historic bridge railing is retained behind the guiderail and approximately one-third of the original bridge railing was replaced during the 1986 rehabilitation. The original railing, replacement railing, and guiderail do not meet current Manual for Assessing Safety Hardware (MASH) criteria. Approach guiderail is present at both sides of the bridges, and while adequate, does not meet current standards. Public input indicates use of the structure by pedestrian and bicyclists, but the bridge does not offer protective accommodations (i.e., sidewalks, adequate shoulder, or shared lane) for these users. Headache bars were installed at a height of 8'6" tall to limit overweight vehicles in 2016. Bridge Closed signs, Type III barricades and gravel piles were installed in October 2019, closing the bridge to all users. Continued usage from pedestrians and bicyclists has been reported via public survey data despite the closure.

Photo 3 - Skinnners Falls Bridge: Typical Guiderail across Structure Looking Ahead

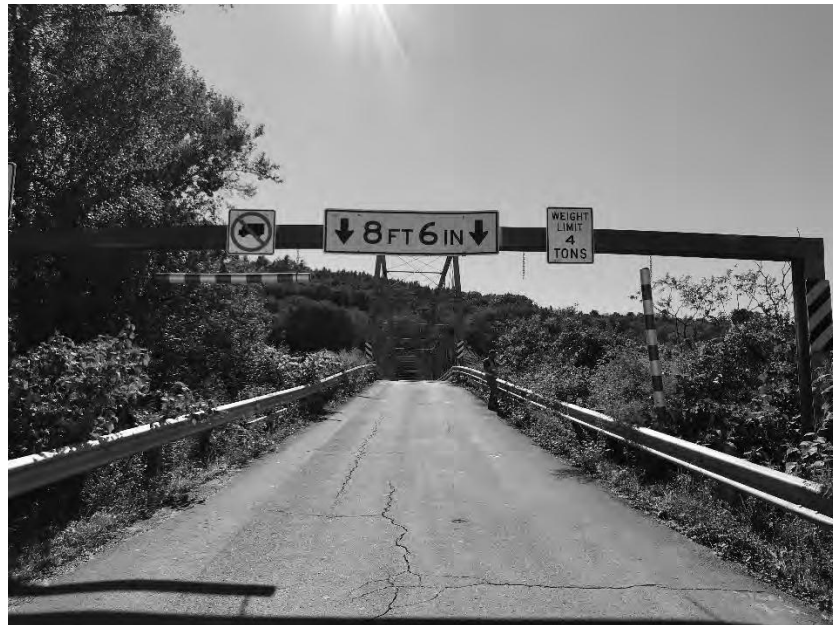
Photo 6 - Skinners Falls Bridge: Headache Bar at NY Approach

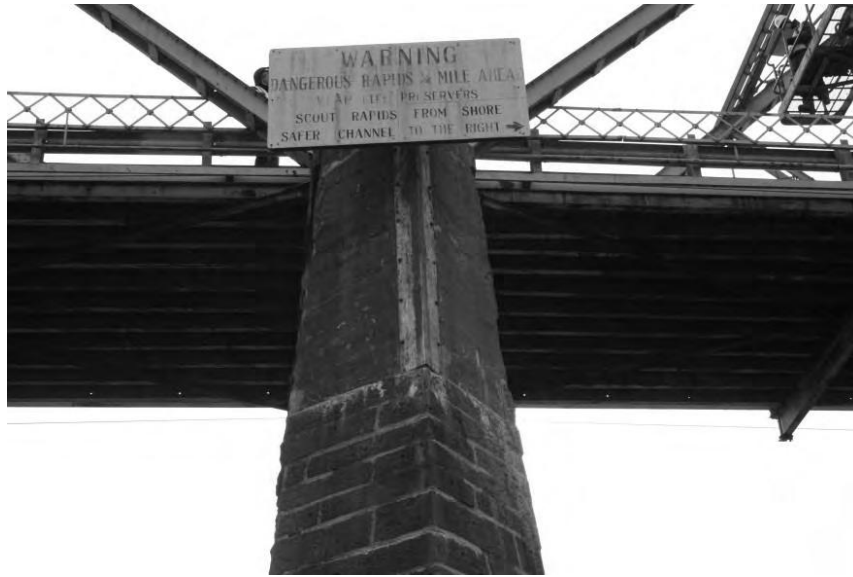
Photo 27 - Skinnners Falls Bridge: Steel Cap at the Top of the Upstream Nose of Pier

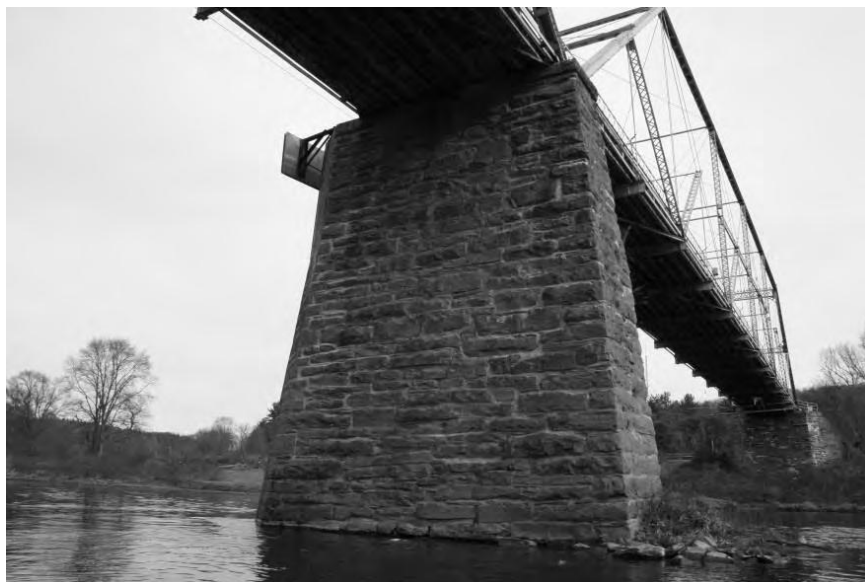
Based upon the most recent bridge inspection, the NBIS condition rating for Channel Protection is 5 (Fair Condition). The channel flows on a good alignment through both spans. No scour exists at the abutments however, minor scour exists at the pier with the stone footing exposed at the upstream end. Placed rock (rip-rap) surrounds the pier.

Photo 28- Skinnners Falls Bridge: Sediment Island with Vegetation Downstream of Pier

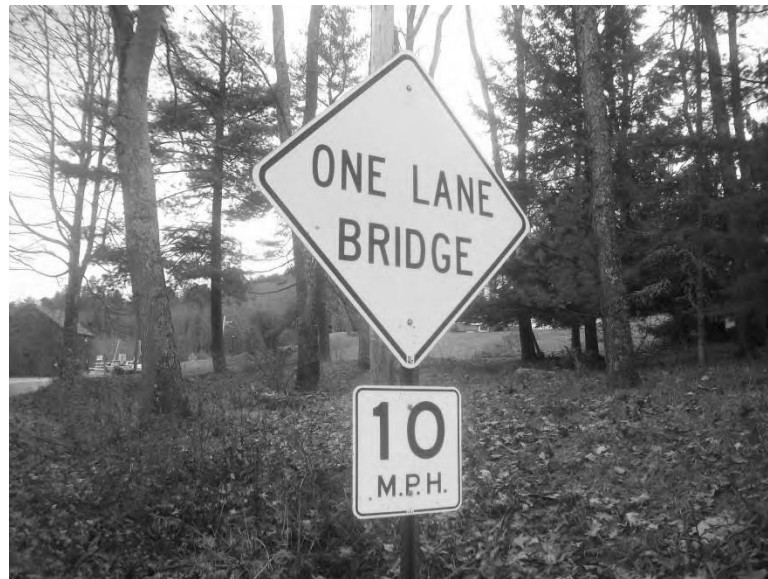
Photo 30 - Skidders Falls Bridge: Near Advanced "ONE LANE BRIDGE" Sign and 10 M.P.H. Advisory Placards
